The Measured Impact of Erosion on the Rotodynamic and Performance Characteristics of a Mixed Flow ESP

Gerald L. Morrison

Professor of Mechanical Engineering
Texas A&M University
College Station, Texas USA

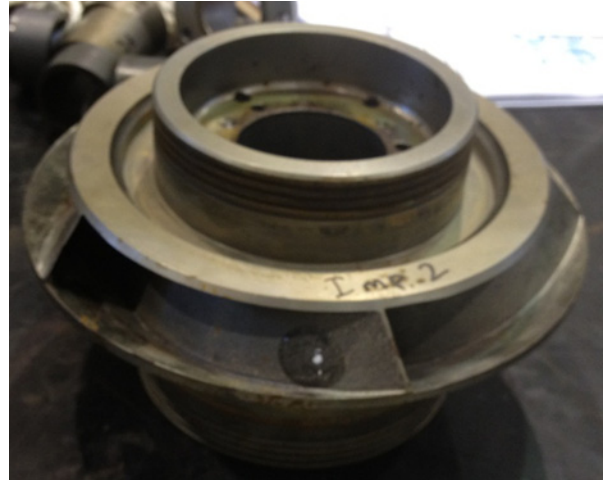
Figure 7. Second stage impeller side view

Each impeller has two labyrinth seals on its top and bottom as seen in Figure 7. Each seal consists of four grooves with the function of restricting the fluid secondary flow paths. They are also an important component of pump rotor dynamics because they function as non-contact, centrifugal stabilizers during impeller rotation. Thus they help maintain shaft life, bearing life and pump life. Impeller dimensions including the labyrinth seal dimensions were measured periodically and weighed to monitor wear. Proximeter probes are also placed on the impeller seal to monitor shaft orbit and vibration. Pump performance curves are recorded periodically as well to monitor performance and compared to erosion and vibration data.

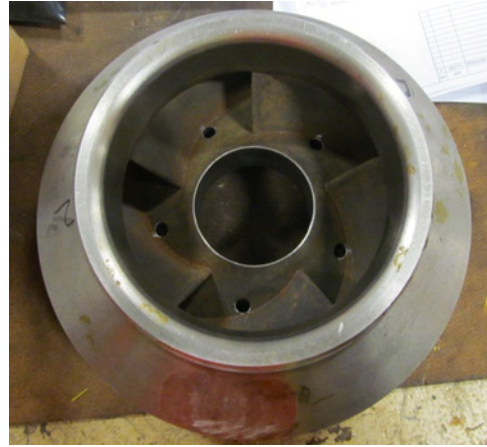
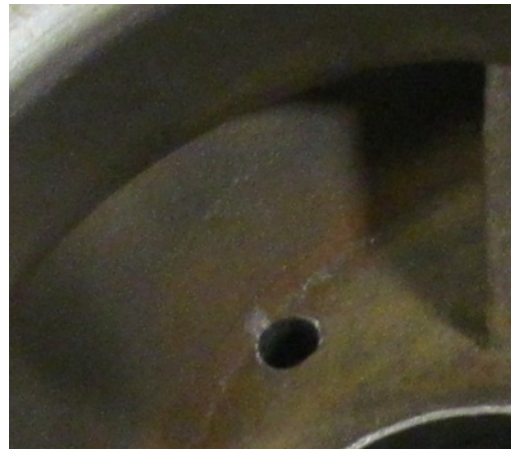
Figure 9. Impeller Balance Holes Base Condition, Inlet

The original impeller balance hole conditions are shown in Figure 9. Figure 10 illustrates that a groove due to erosion after 117 hours occurred on the main hydraulic flow side of the impeller. This groove is caused by the wake that is present behind the jet of fluid passing from the high pressure region behind the impeller into the main flow, much like erosion around bridge piers. The size of the groove changes from one stage to the other. Stage one has the smallest groove at the balance hole. Stage number two has a larger groove caused by erosion and stage number three has the largest groove due to erosion.

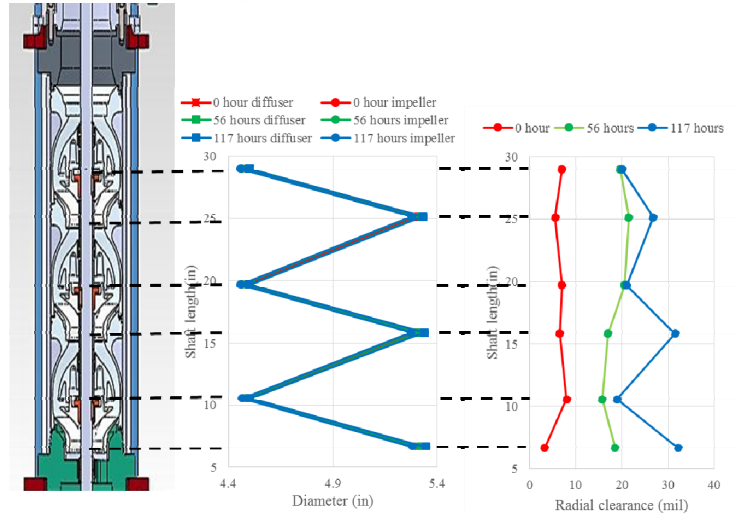
Figure 27. Radial clearances between impellers and diffusers at different erosion times.

As Figure 20 has indicated, the bearing at the pump inlet (Shaft 1) has the most wear and the orbits tend to be circular. Shaft 2 has a significantly smaller orbit which begins relatively circular but become elliptical at the end of the study. Shaft 3 bearing maintains a relatively circular orbit with a maximum amplitude between Shaft 1 and Shaft 2 bearings. The interesting observation is that the two impeller seals have ultimate orbits smaller than Shaft 1 and 3 while Shaft 2 is smaller. It appears that as the wear progresses the impeller seals are starting to replace the bearings as the load carrying component. Figure 27 combines the data of the physical diameters of the bearings and seals into one figure. It can be seen that as the erosion progresses the clearance of the bearings exceed the clearance of the impeller seals by a considerable amount. The impeller seals ultimately reach a radial clearance of 20 mils while the bearing range from 26 to 32 mils. This is further evidence that the impeller seals have become the pump bearings.

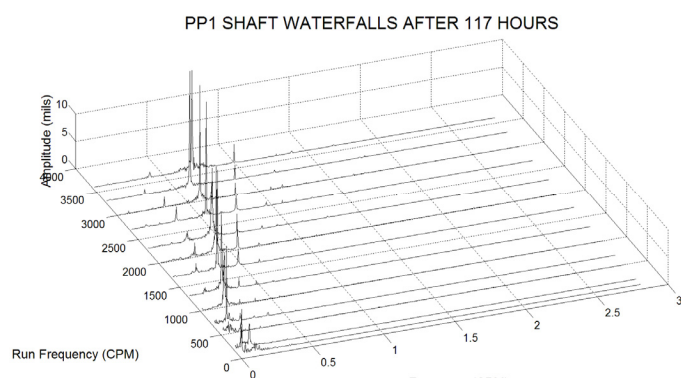
Figure 29. Shaft 1 (PP1) start up waterfall plot after 117 hours of erosion.

The evolution of the frequency content of the pump vibrations due to erosion as indicated by the PP1 proximeter probe for the Shaft 1 location are shown in Figures 28 and 29. Water fall spectra of how the vibration of the pump changed with erosion time is presented in Figure 28 for one of the proximeter probes. At the start, the primary vibration is at the pump speed with a 2X harmonic and a slight indication of 1/3 and 2/3 components. As wear progressed, the sub harmonic components increased with the 2/3 component becoming dominant at the end of the test. Also included in Figure 29 is a ramp up water fall plot showing how the 2/3 harmonic tracks with the speed of the pump.

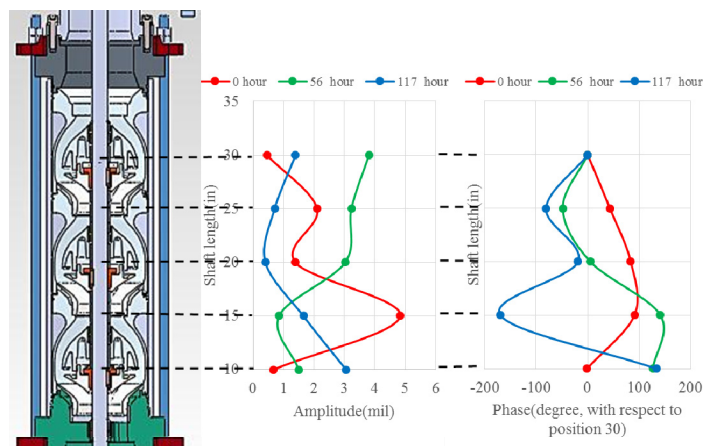
Figure 30. Synchronous vibration amplitude and phases (60Hz).

Since there are two primary frequencies present in the spectra which change in dominance with wear, the contribution of each to the orbit of the pump components was investigated. Figures 30 and 31 present the amplitude and phase (relative Shaft 3) of the 60 Hz (3600 RPM, run speed) and 40 Hz components. These data were obtained using spectral analysis of the proximeter probe data. All the data were obtained using a simultaneous A/D system so that phase information is maintained. A band of frequencies were used centered about the two specified frequencies. The fundamental (60 Hz) component has amplitudes below 5 mils for the entire erosion process. The phase varies about 90° initially but increases to over 180° after 117 hours indicating a change in the vibrational mode. The sub-synchronous mode has the largest amplitude reaching a maximum of 12 mils at 117 hours. The values at 0 hours are not shown since they are less than 1 mil. The phase change is essentially constant indicating a whirling type instability precessing at 2/3 the pump running speed.

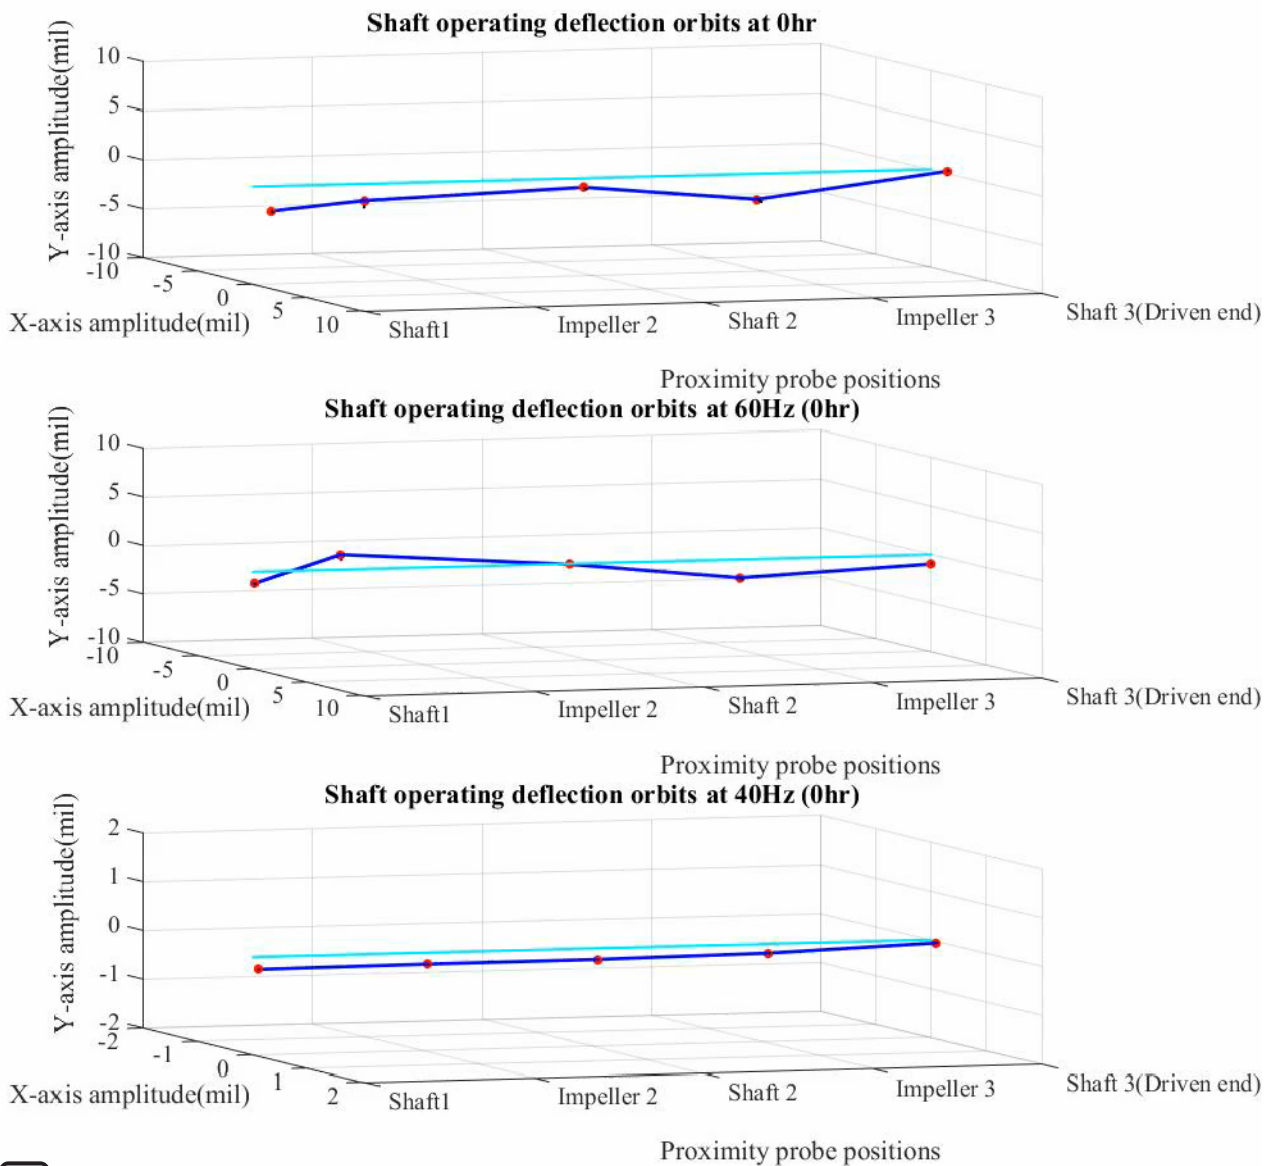
Figure 32. Rotor orbits at 0 hours.

Figure 32 presents the initial startup condition (0 hours) of the pump. The 60 Hz component and the unfiltered data show the rotor vibration is contained primarily in the 60 Hz component. The 60 Hz component clearly shows a phase change along the axis of the pump. The 40 Hz component is presented on a scale the expands the motion by a factor of five and shows a constant phase indicating a whirling motion. The bearings have the smaller orbits than the impellers. The spikes on the orbit for impeller 2 are flats that were machined onto the seal for phase reference.

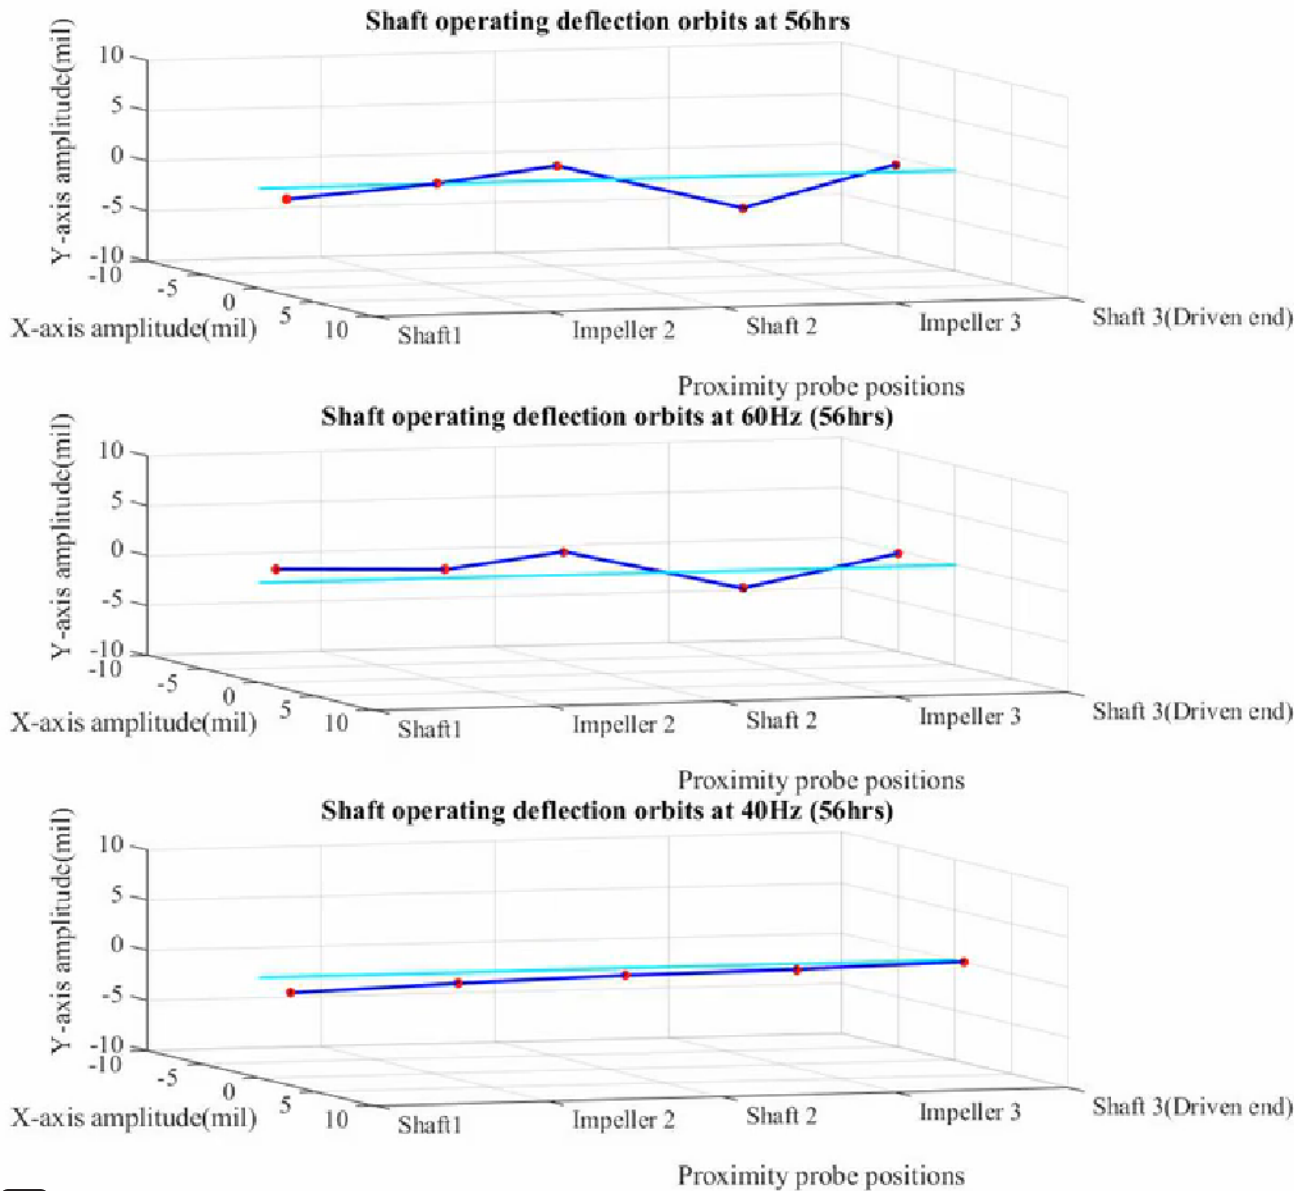
Figure 33. Rotor orbits at 56 hours.

Figure 33 presents the results at 56 hours. All three graphs have the same scales on the motion. The amplitudes of the motion at the bearings are increasing more rapidly than the impellers. Again,

most of the motion is in the 60 Hz mode whose phase varies along the pump axis. The 40 Hz whirling mode is increasing in amplitude reaching a maximum at the pump inlet.
